# THE GREAT TRAIN WRECK OF 1918

THE WORST TRAIN WRECK IN AMERICAN  
HISTORY HAPPENED IN NASHVILLE TN

- Happened at 7:20 AM, July 9, 1918
- Nashville, TN :Dutchman's Curve, just west of downtown (behind current location of St. Thomas Hospital)
- 101 dead
- Over 171 injured
- Two trains involved—Train #1 from Memphis and Train #4 from Nashville.

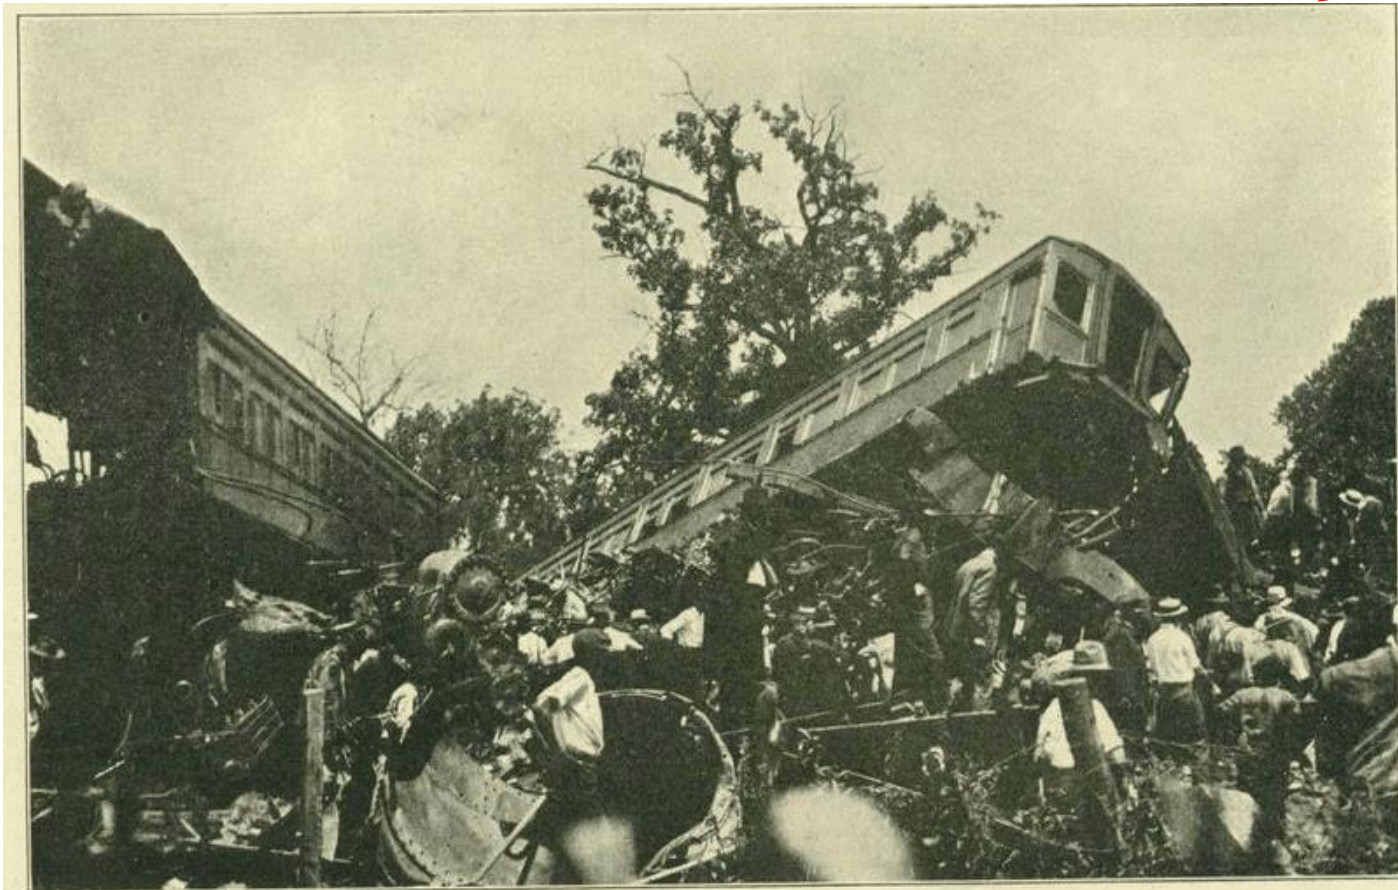
FIG. 2.—VIEW OF DESTROYED EQUIPMENT.

Conductor on #4 train (Nashville) was supposed to watch for Train #1 but got busy stamping tickets for passengers. He mistook a switch engine passing them as the sound of Train #1. But it wasn't.

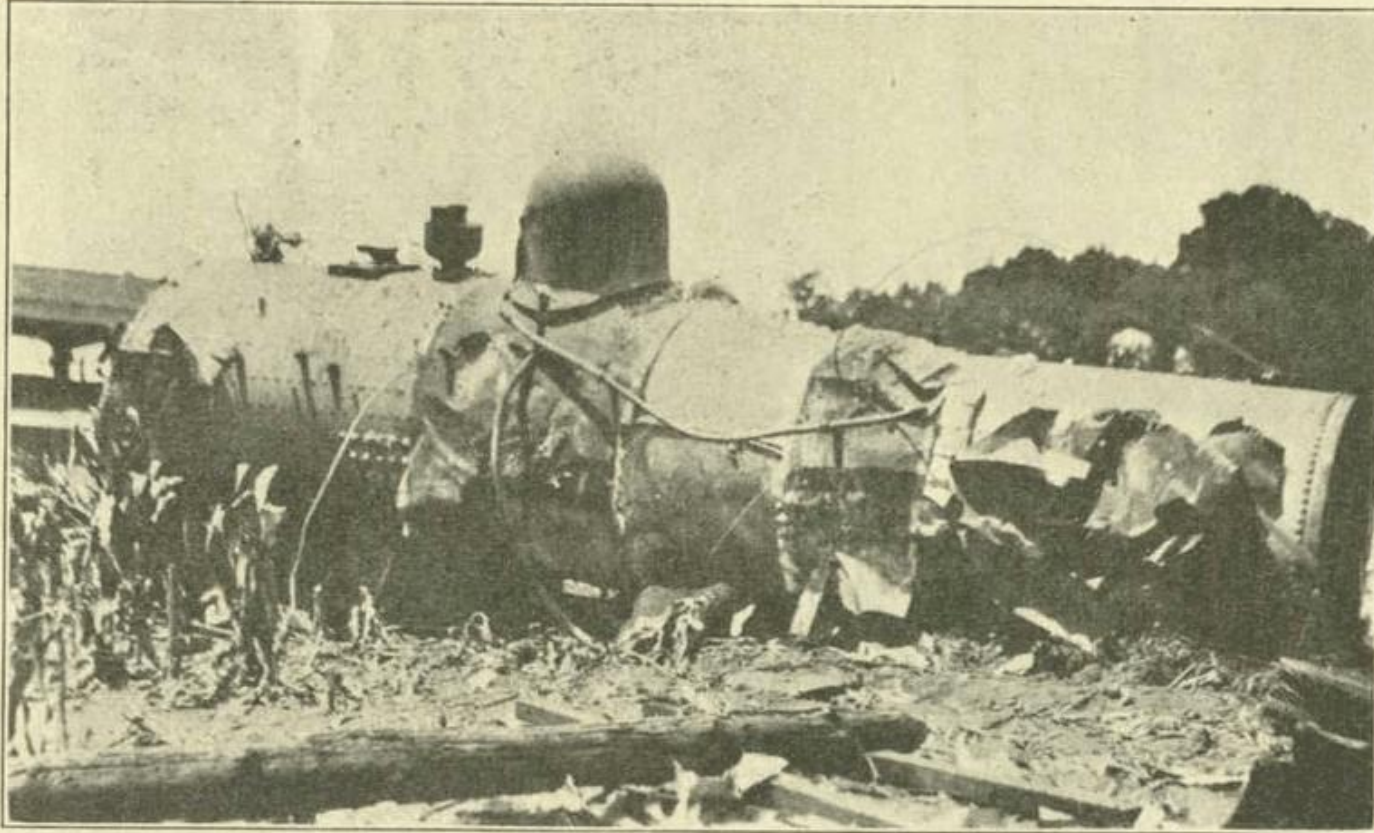
FIG. 3.—BOILERS OF LOCOMOTIVES 281 (TOP) AND 282 (BOTTOM).

Train #1 was running 30 minutes late, so they had sped up to make up time. They expected Train #4 to wait at the junction until they had passed, which was standard operating procedure. But Train #4 was speeding toward them. This is what's left of the boiler for Train #4, the Nashville train.

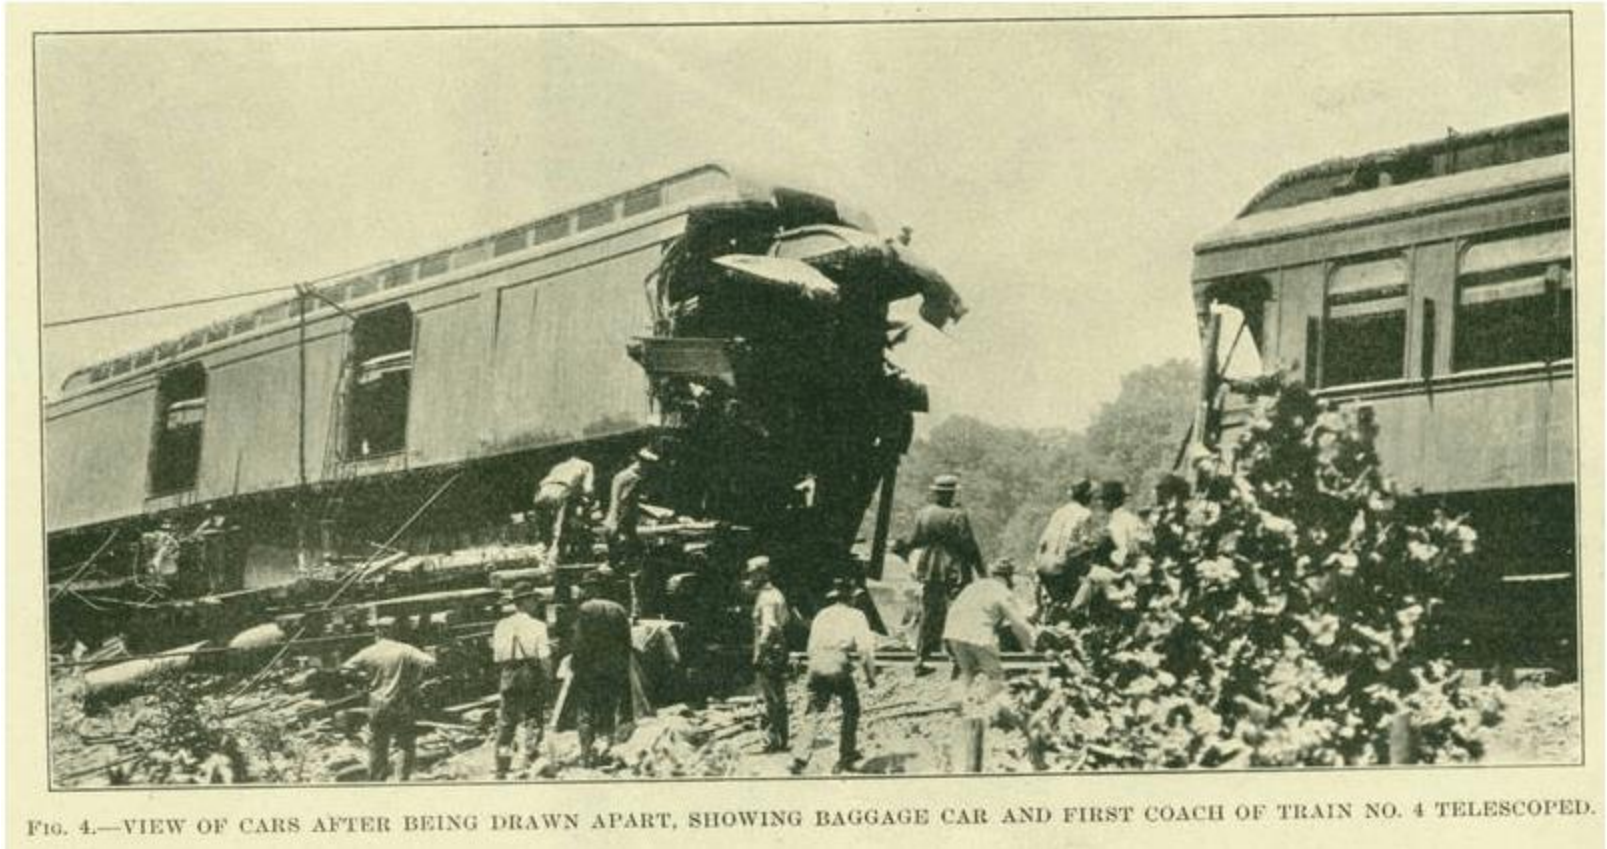
All the cars in both trains, with the exception of two cars in Train #1, were wooden and destroyed upon impact. The few steel cars survived better but ironically contributed to the severe casualties by creating a telescoping effect, where one car was driven into another.

- Results of train wreck investigation:
  - Safety measures were ignored; ICC recommended better training and communication
  - ICC also felt that wooden sleeping cars were unsafe and should be replaced
  - A better system for identifying trains on the tracks was developed since the existing system failed so badly
